Ultrasound for Cooling Water Application

WINTECS CORPORATION

Cooling water System on Air conditioning

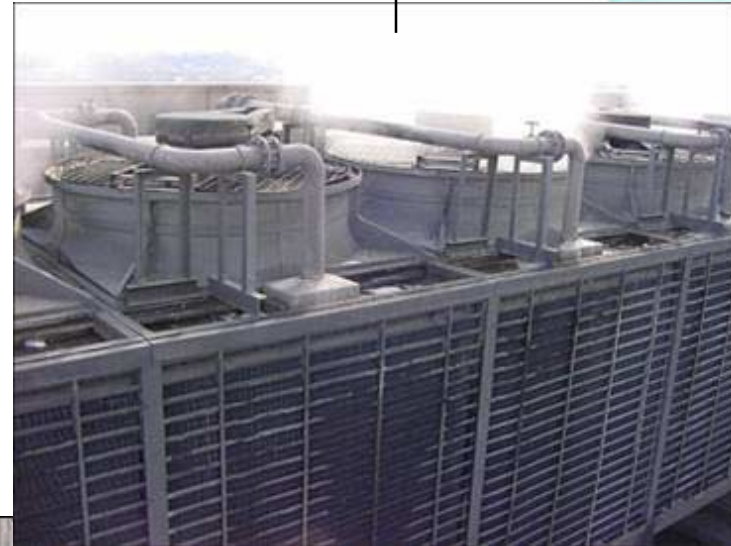
Circulating water : 1,000 tons/h
Holding water : 25m³

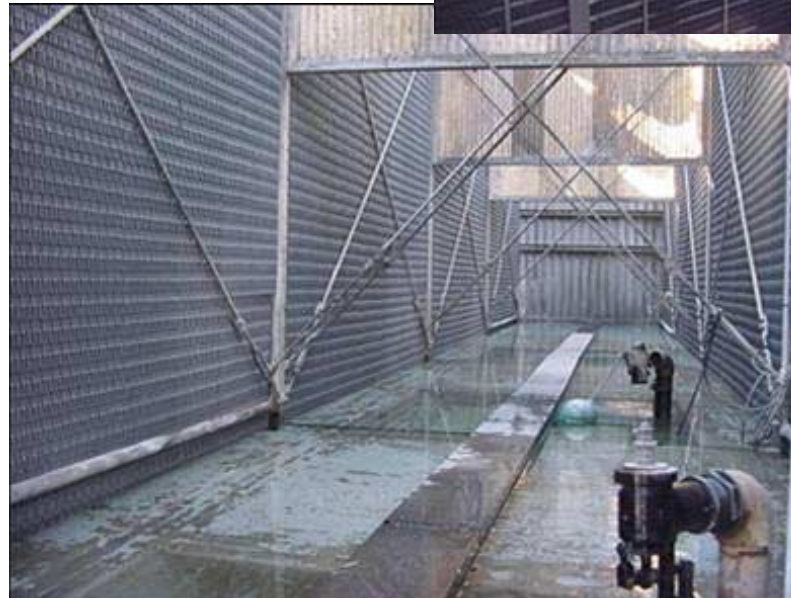
Inside of Tower

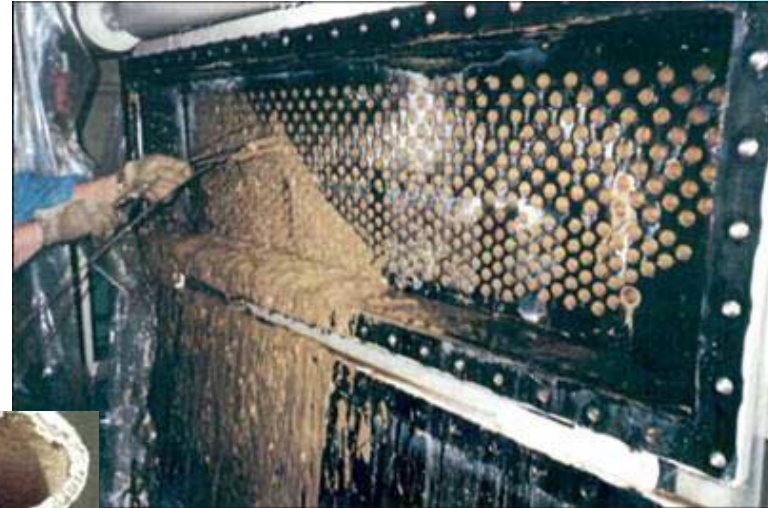
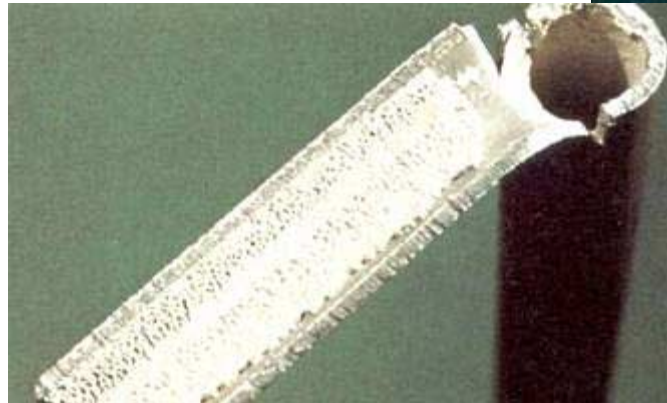
Heavily fouled
Chiller condenser

Scale formed in condenser tube

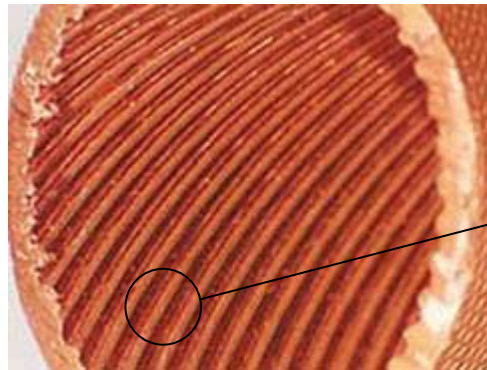
Inside of Condenser tube

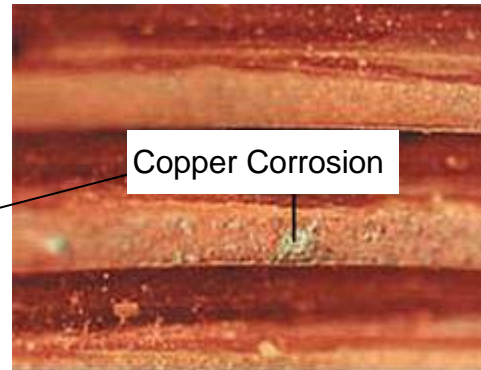
Copper Corrosion

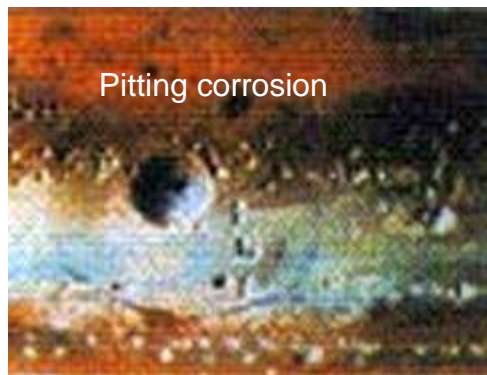
Pitting corrosion

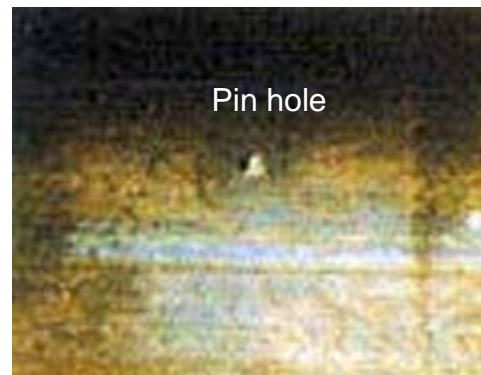
Pin hole

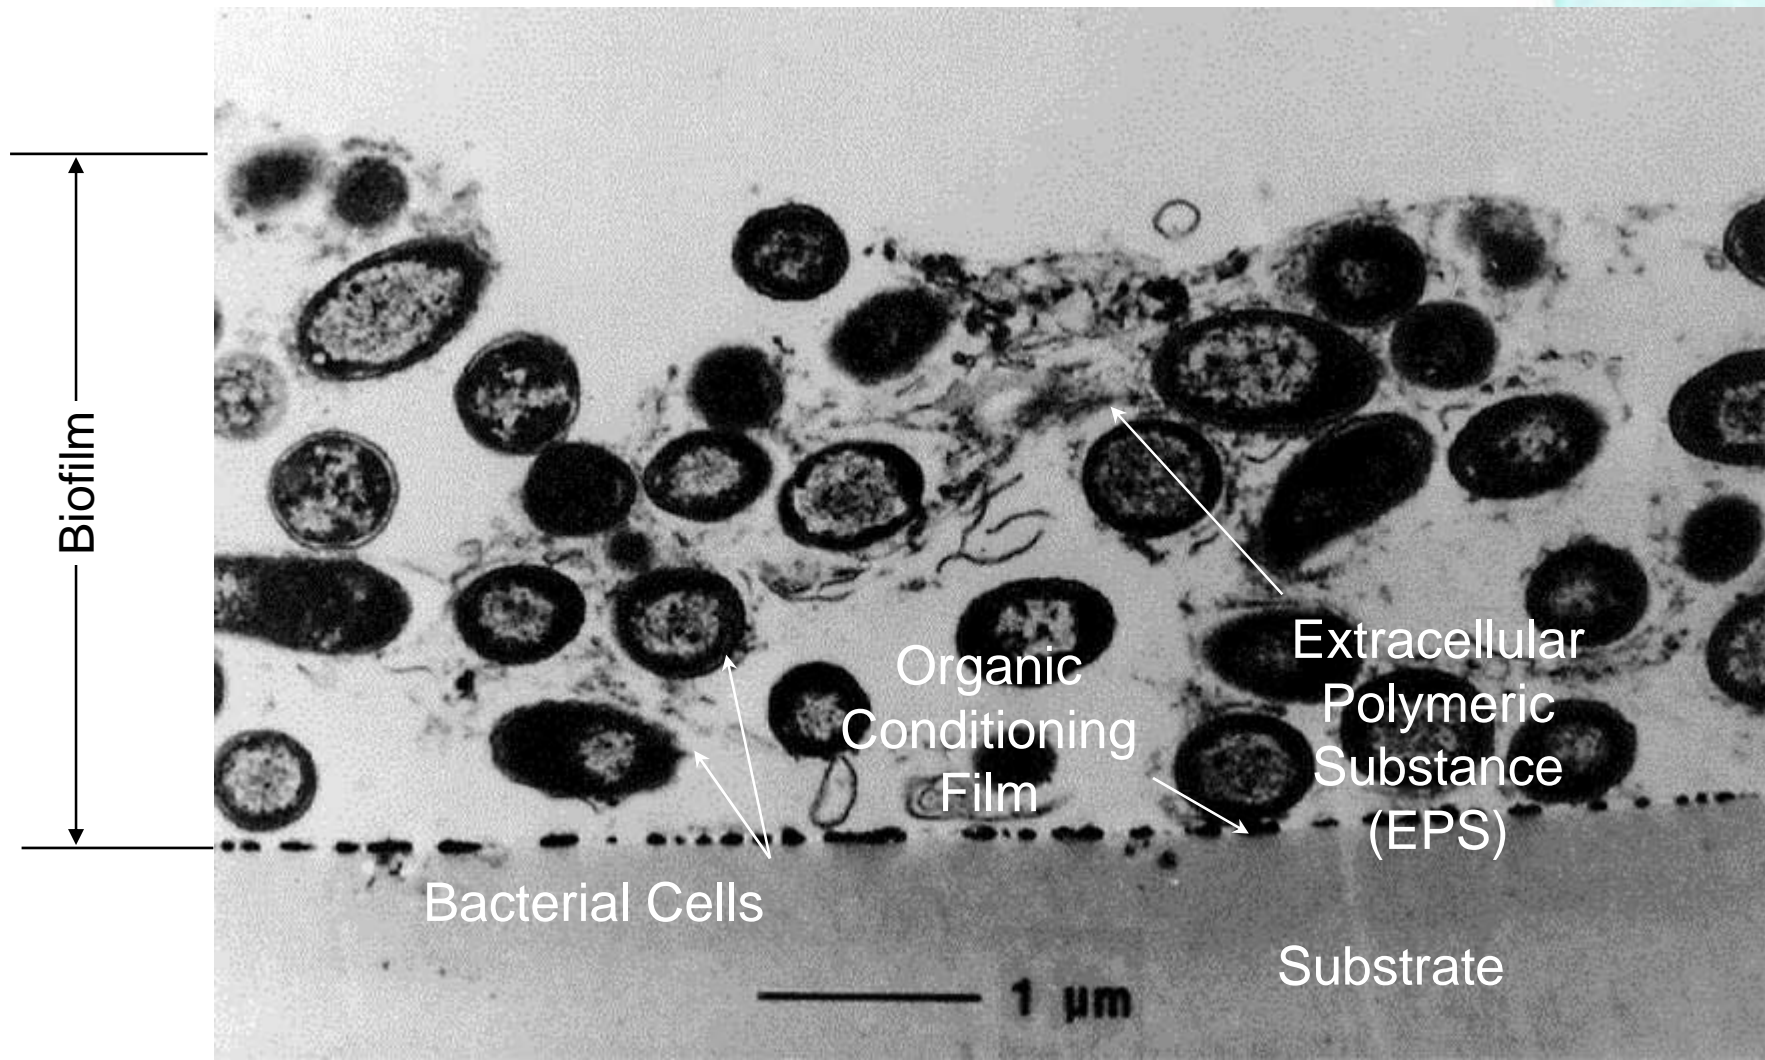
Biofilm Forming Process - Stage 1

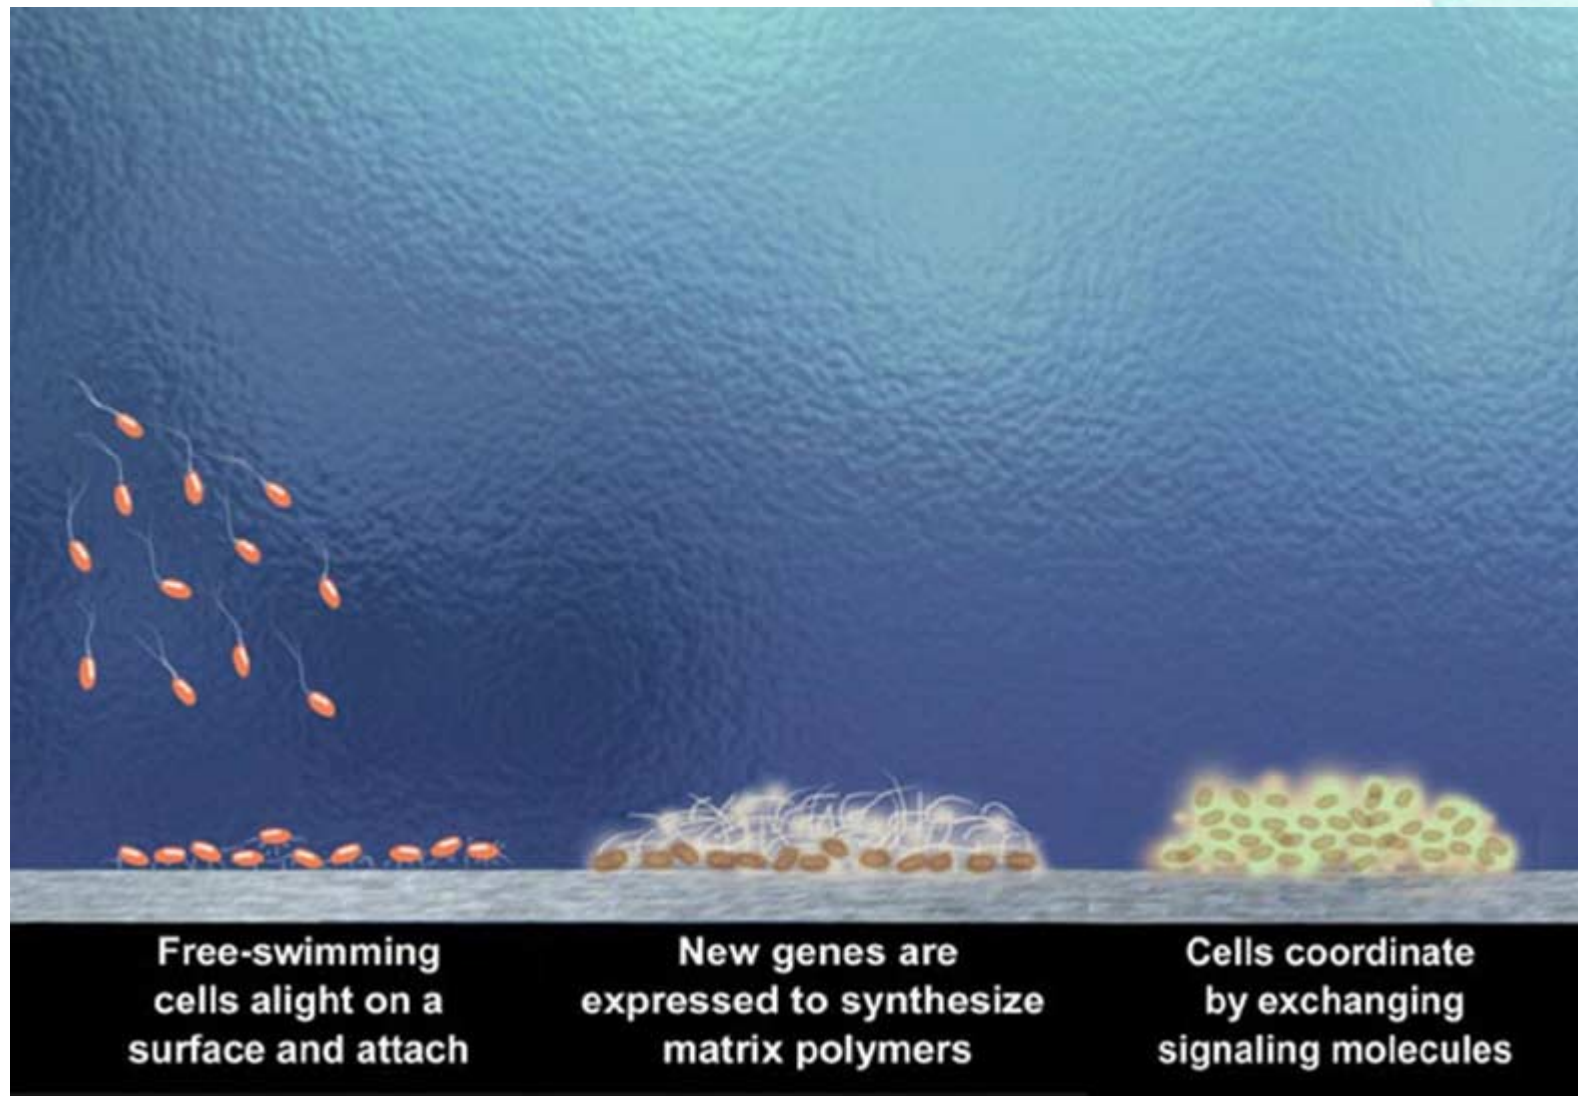
Biofilm Forming Process - Stage 2

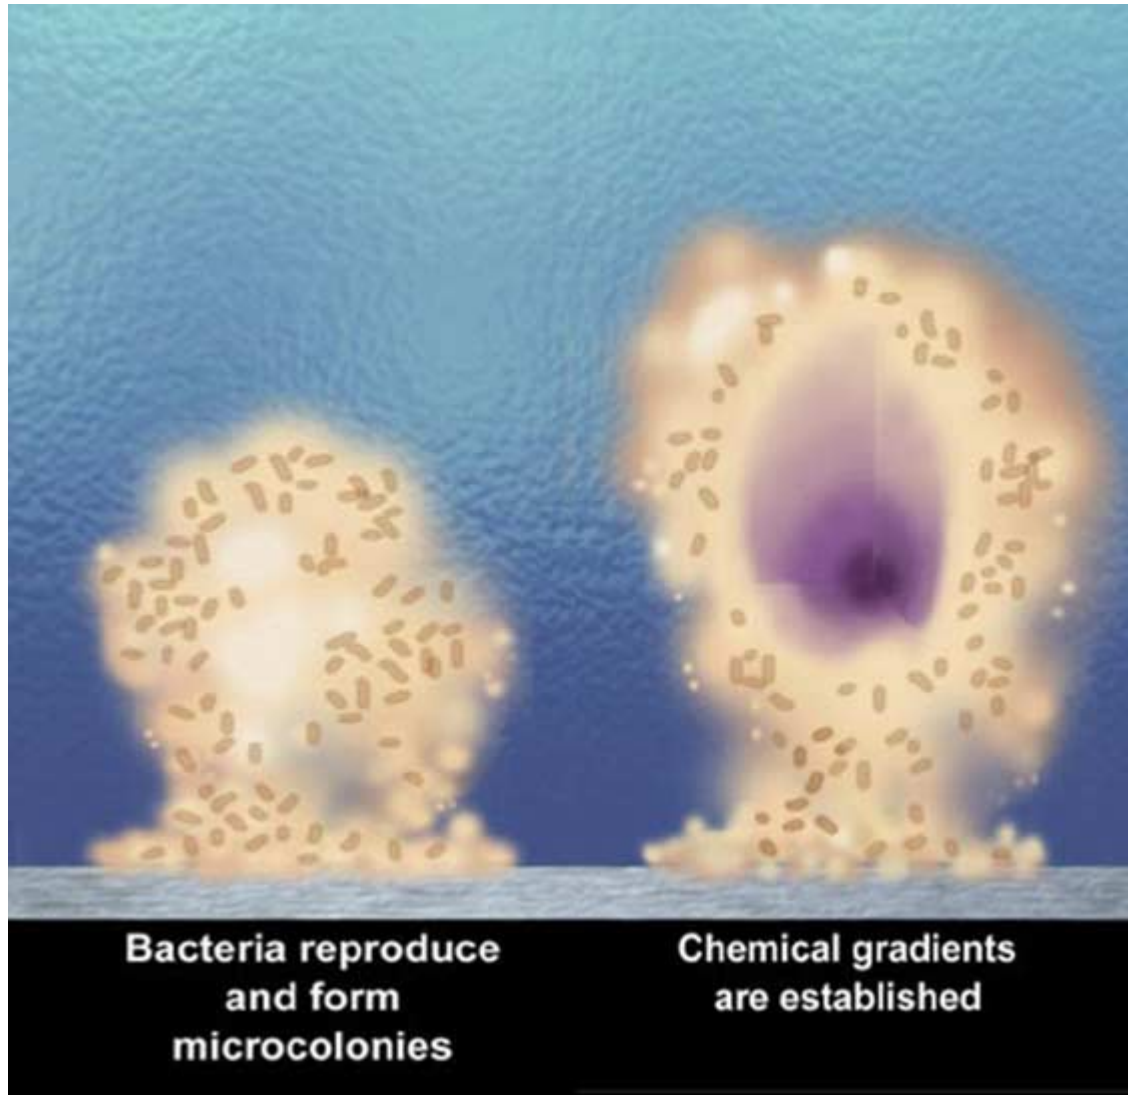
Biofilm Forming Process - Stage 3

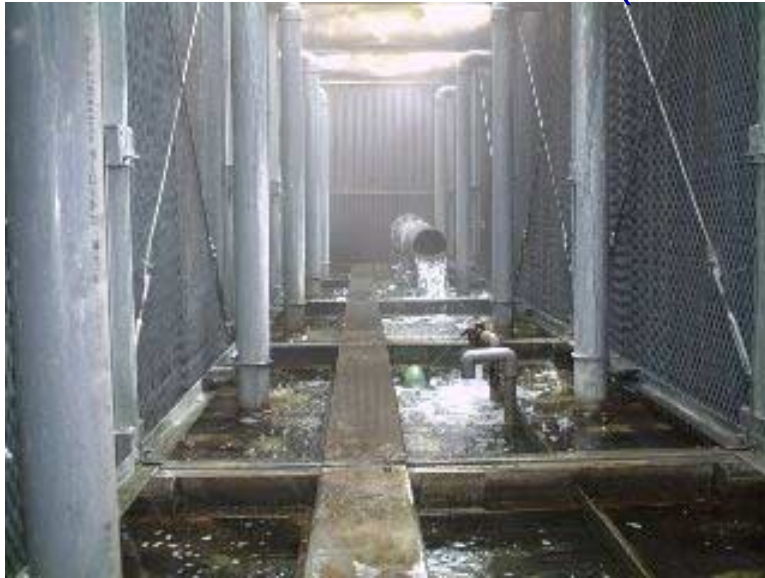
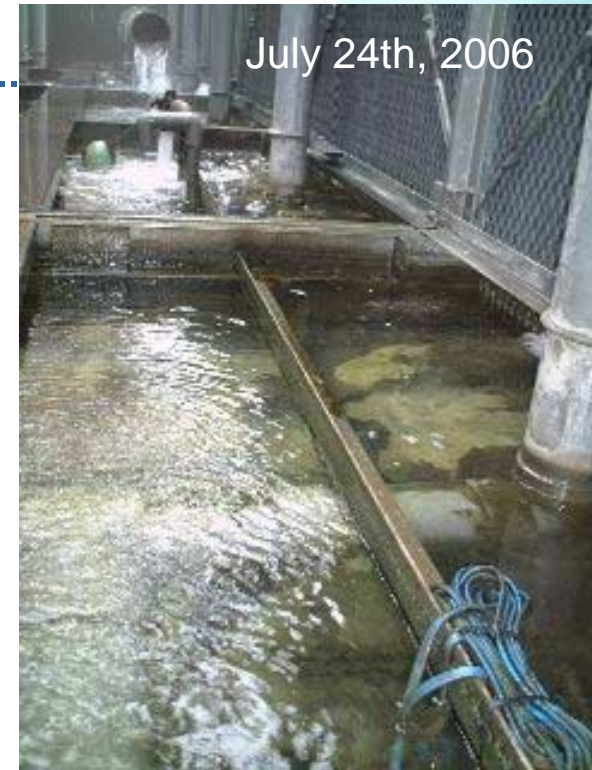
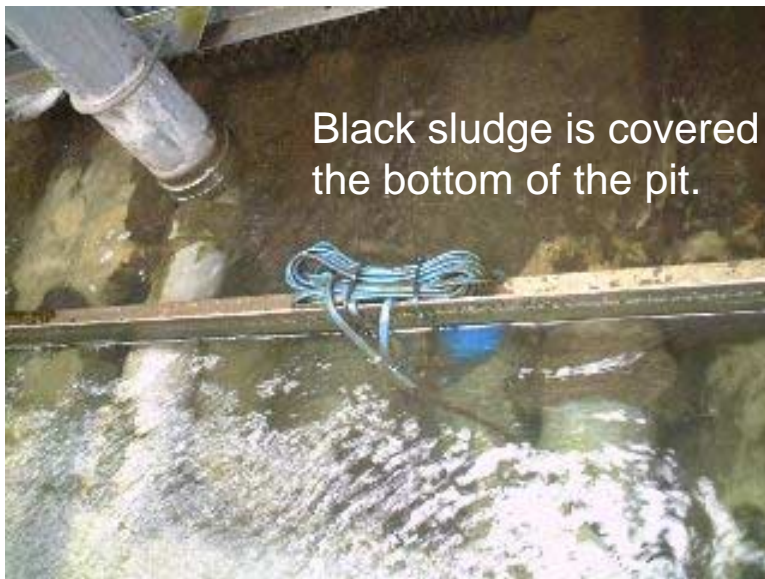
Black sludge is covered
the bottom of the pit.

- Tower pit looks very dirty because of standby in winter time.
- Oxidizing Biocide has been fed by timer several times in a day.
- Organic Bromine Biocide test started from July 21st.

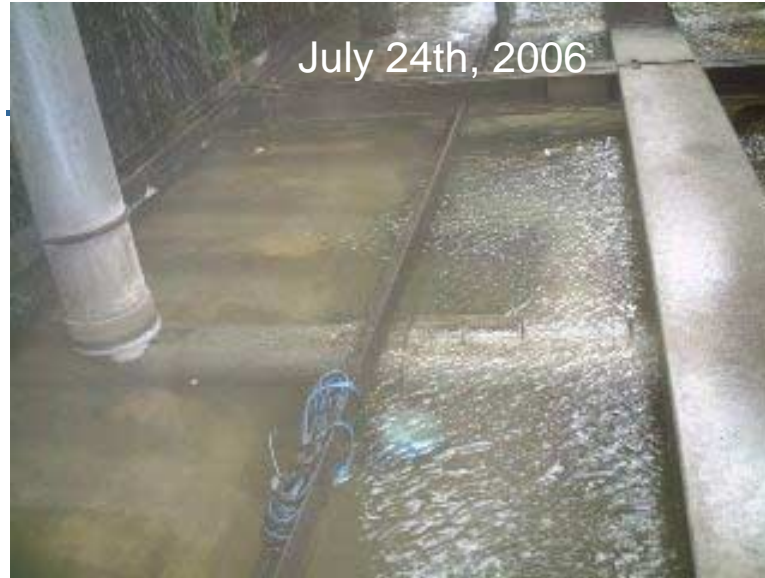
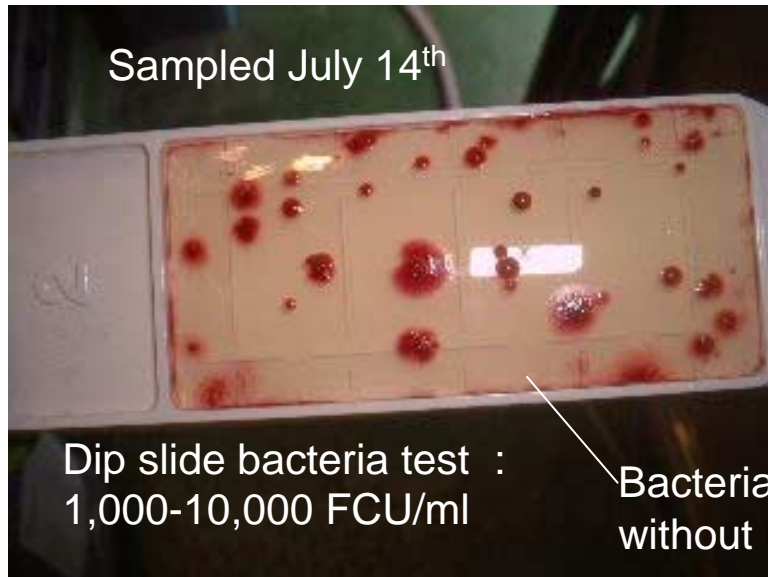
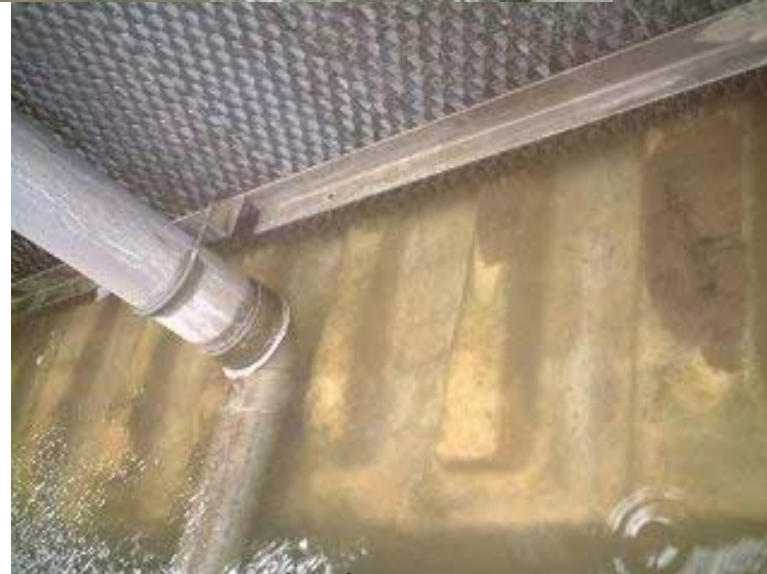
Bacteria count seems to be lower even without Biocide dosing

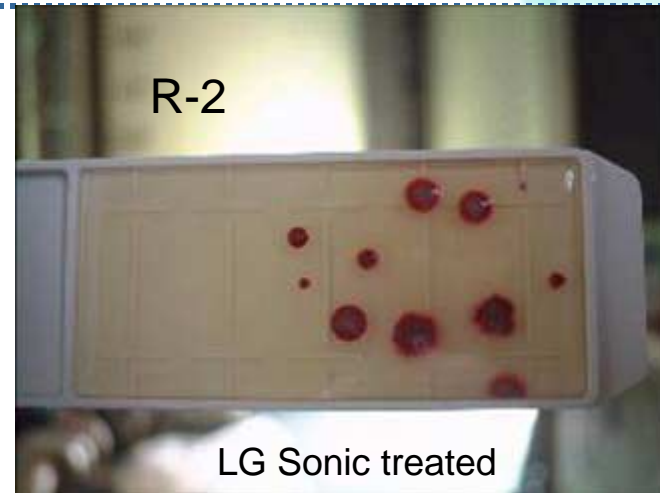
Sampled July 14th

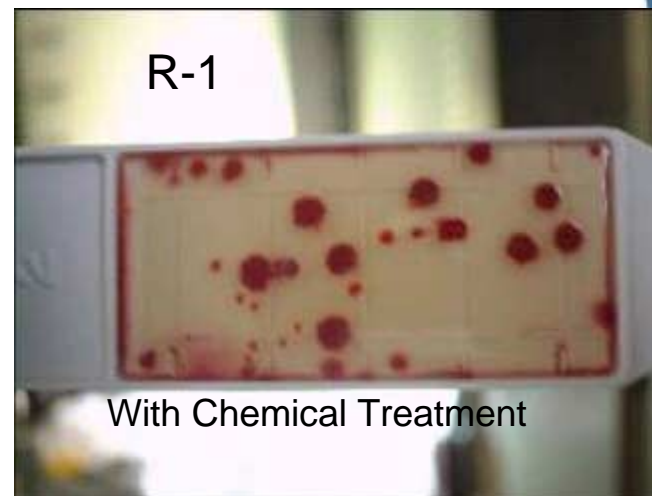
Sampled July 28th
Bacterial count is lower than
two weeks ago.

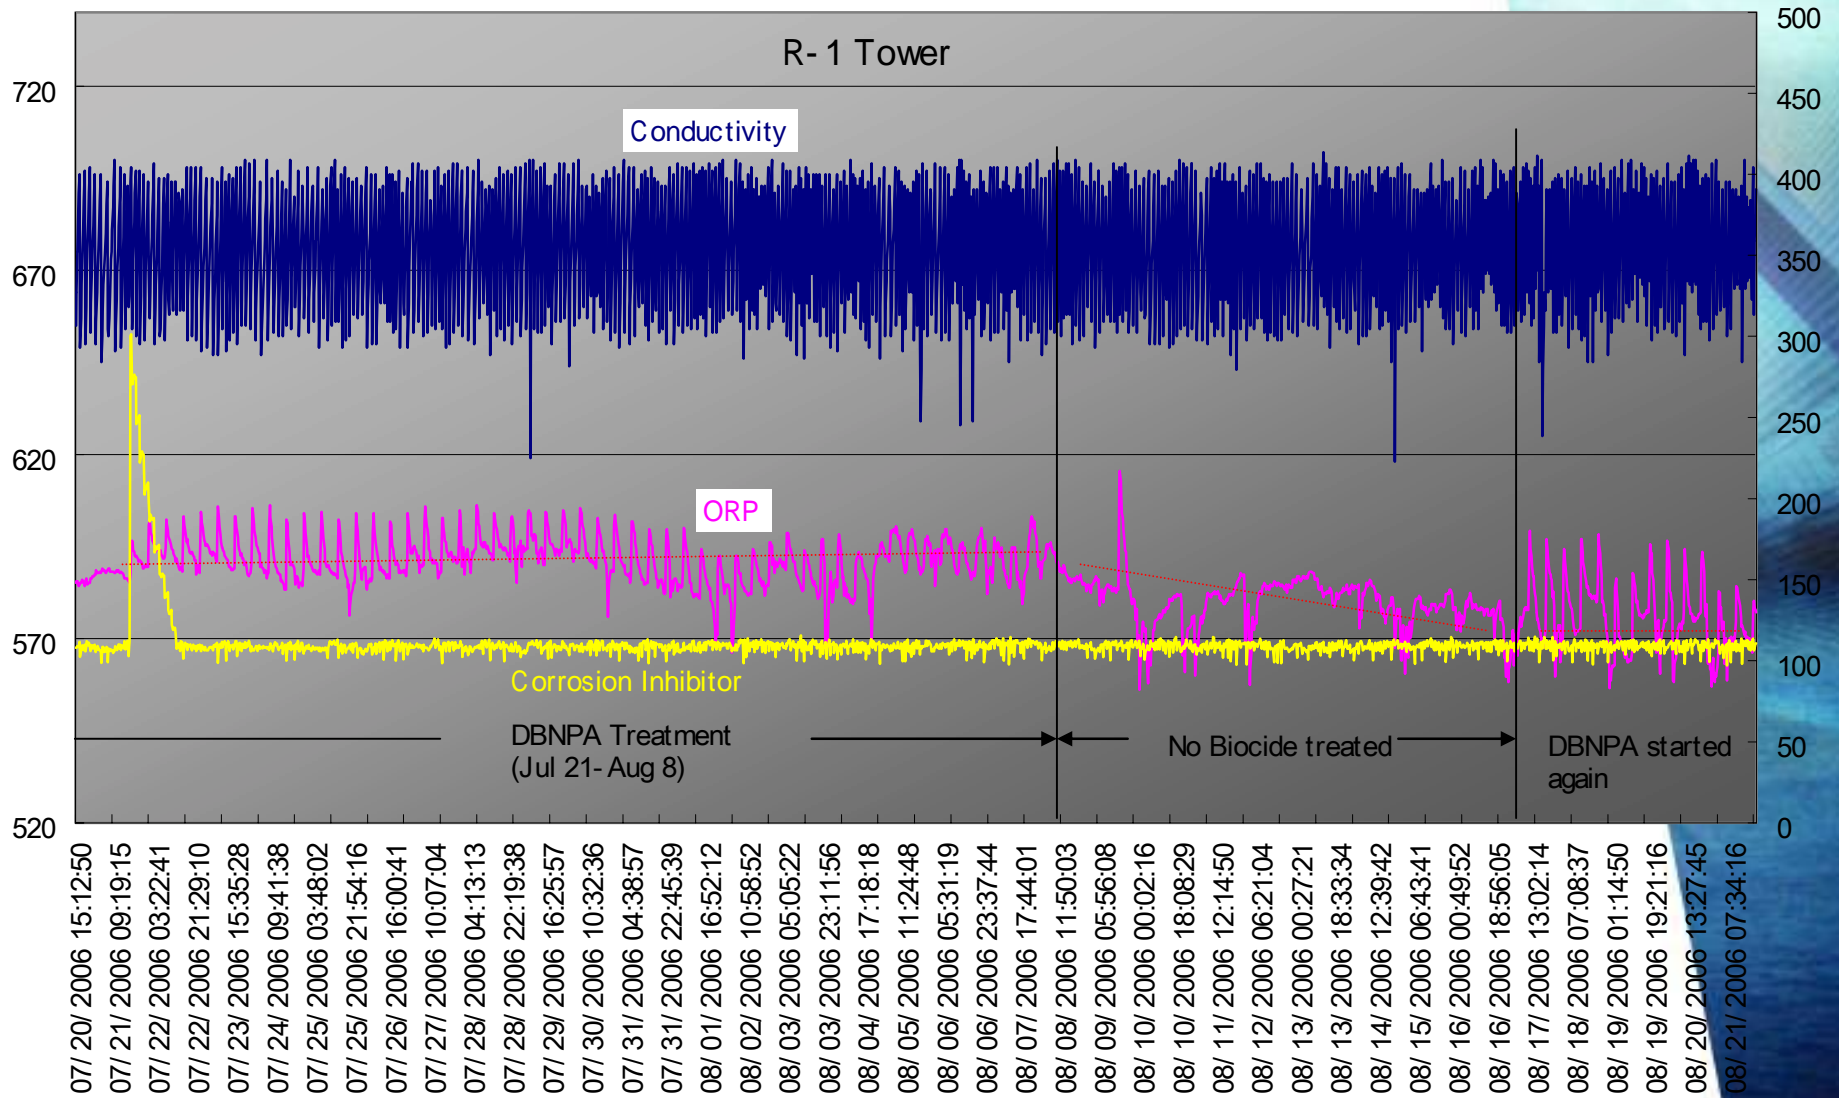
ORP trend on R-1 Decreased after DBNPA treatment

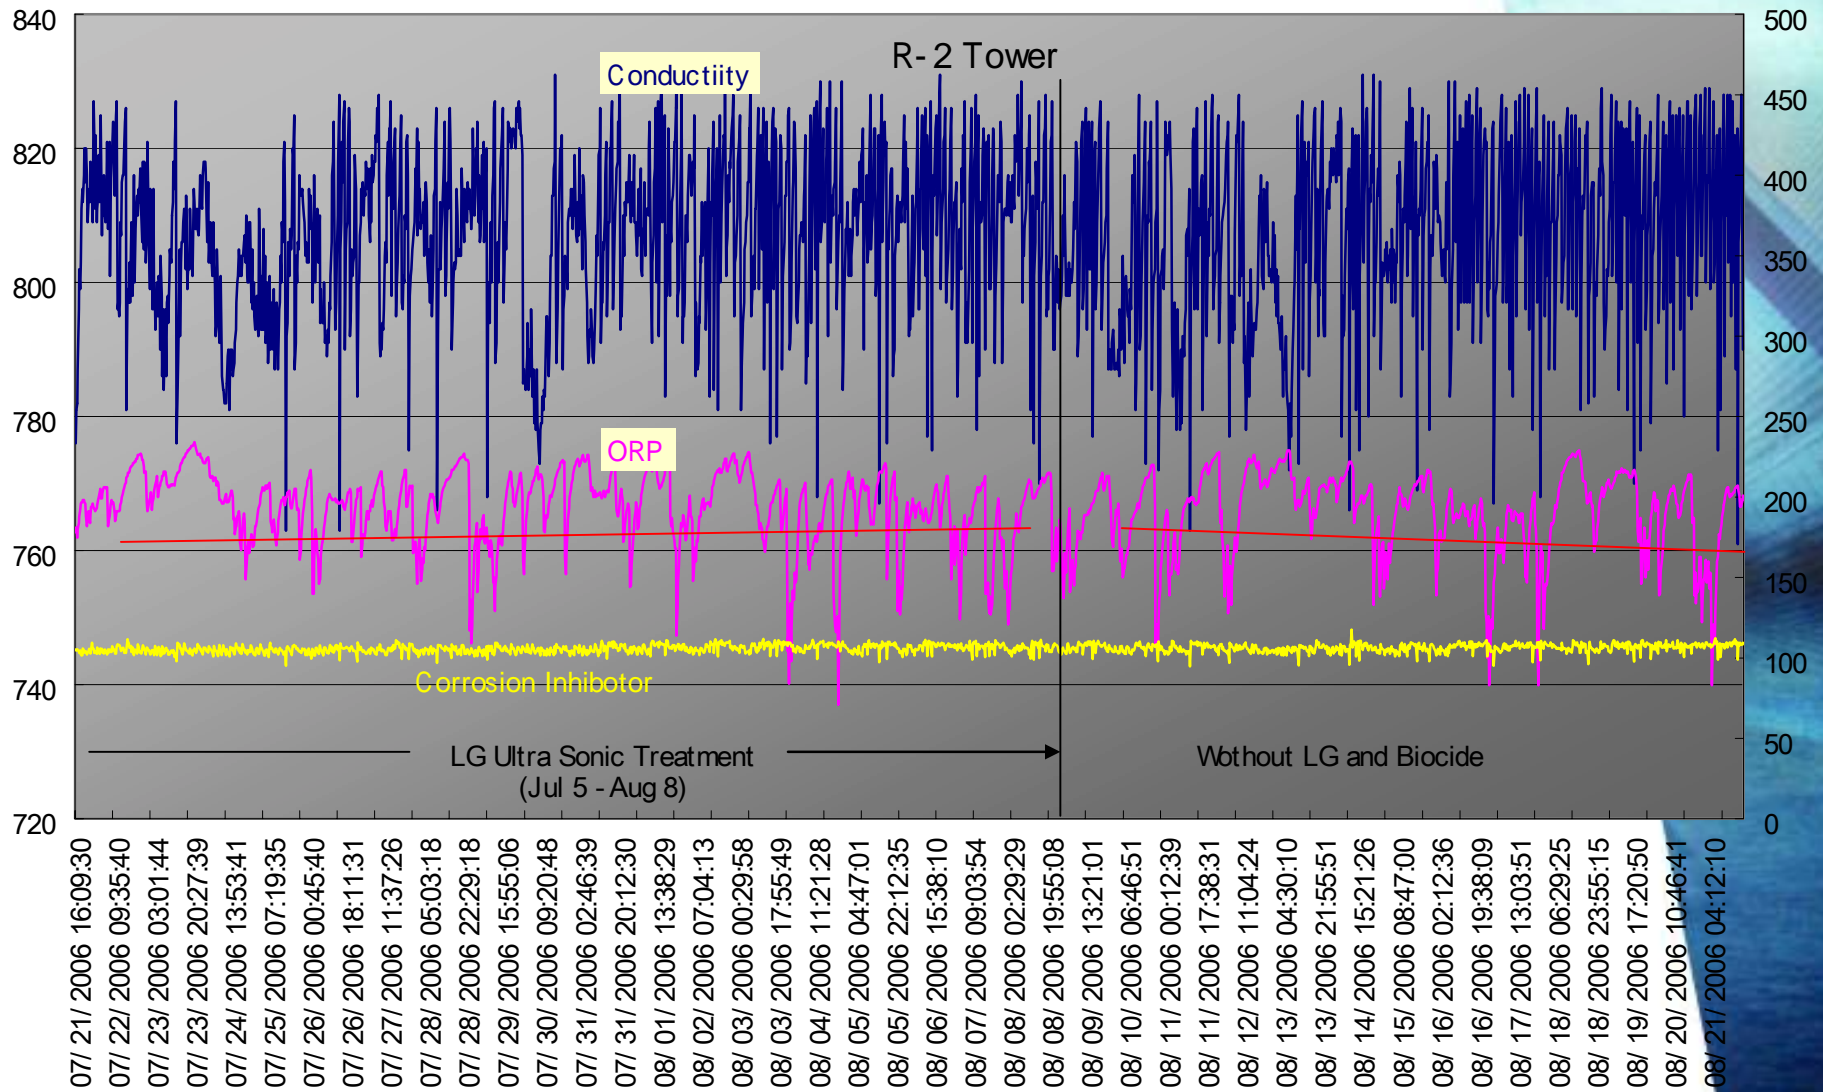
ORP on R-2 Showed Little Change After LG XL Treatment

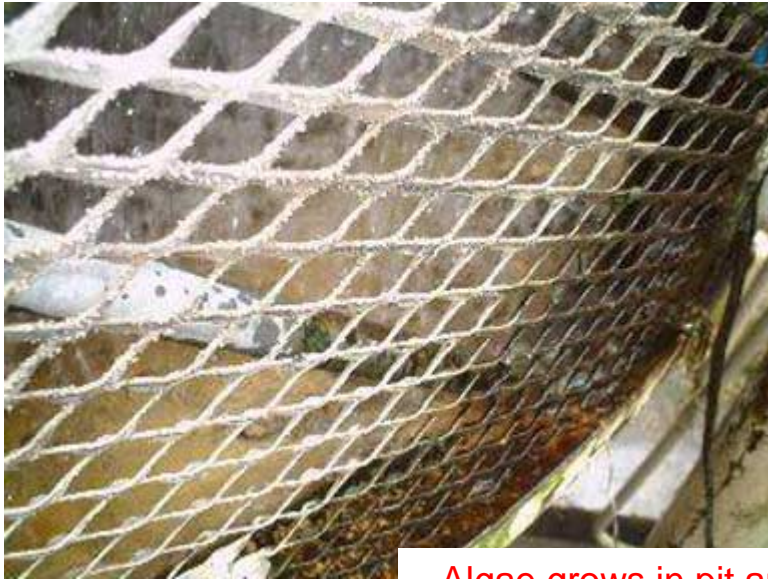
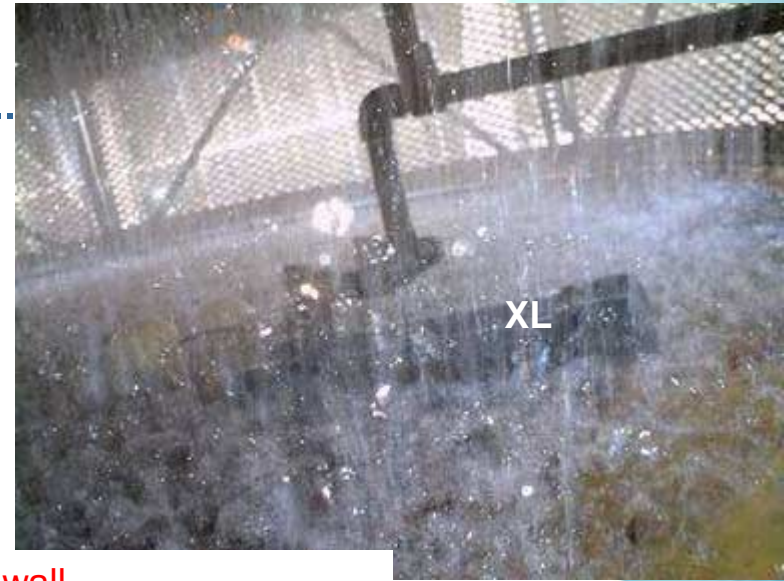
2-2C C-1 (started test in August 7)

- Algae grows in pit and on the wall.

- Bleed water stream shows very heavy algae growth.

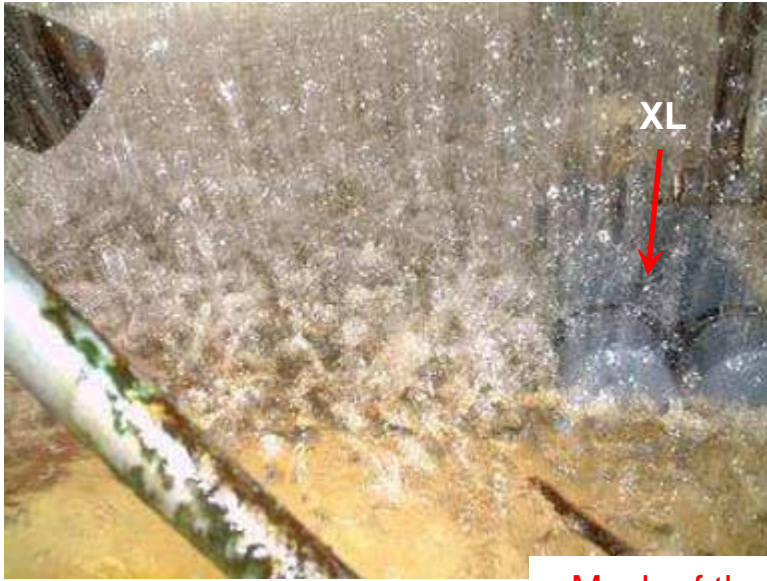
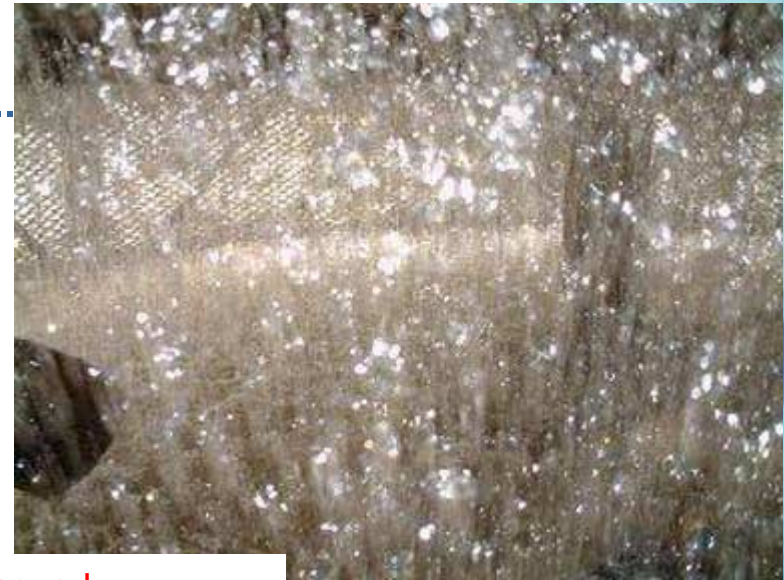
2-2C C-1 (September 9)

- Much of the algae removed.
- Drain stream algae was also reduced.

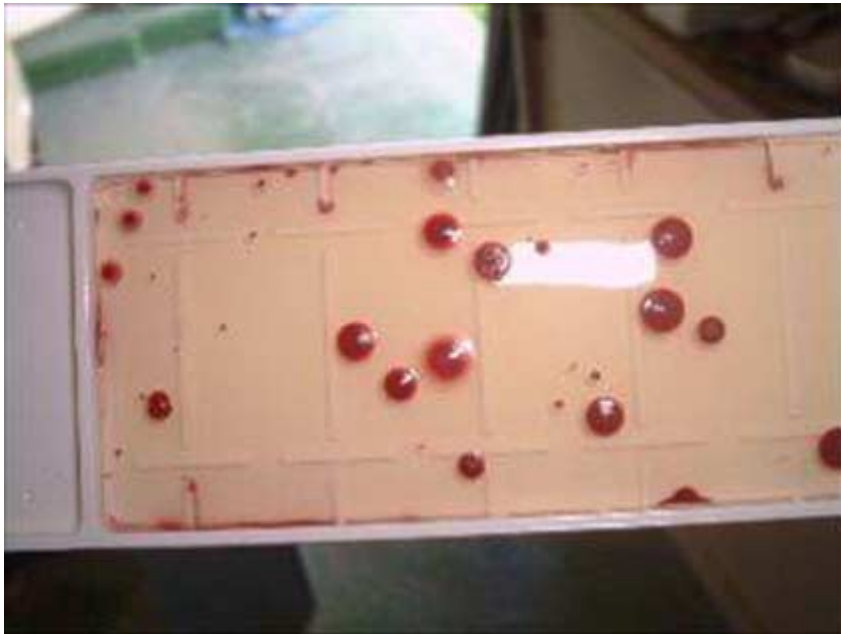
**C-1 Cooling Tower
(with LG Ultrasonic)**

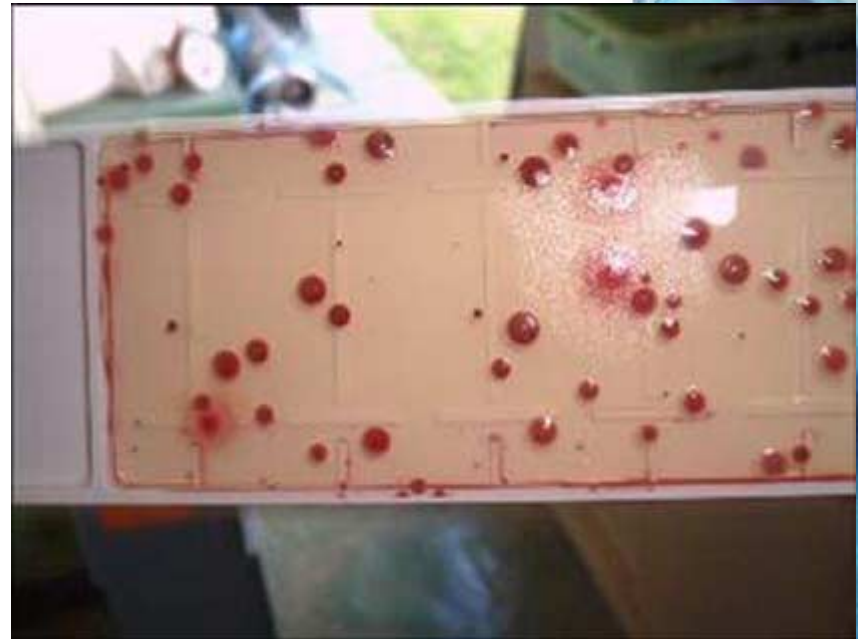
**C-2 Cooling Tower
(with Chemical Treatment)**

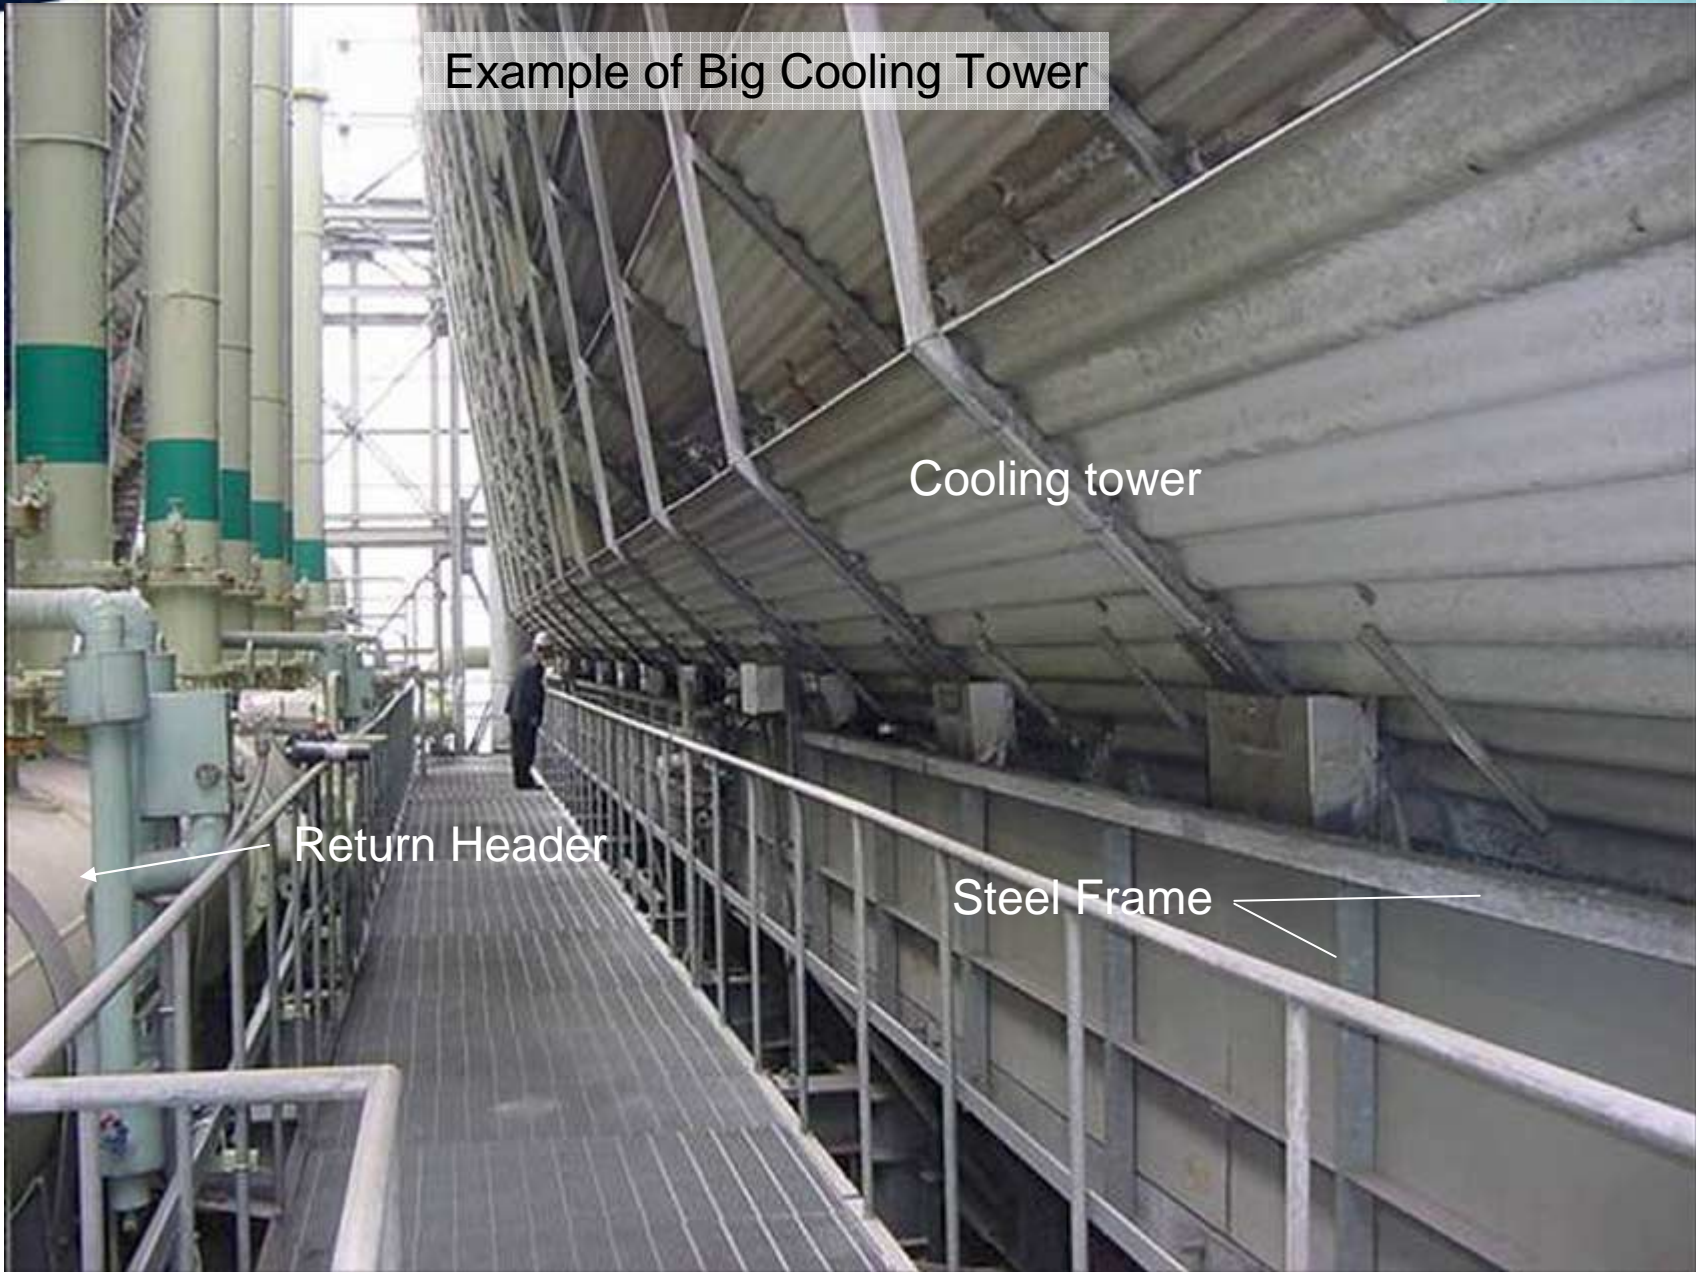
Cooling tower

Return Header

Steel Frame

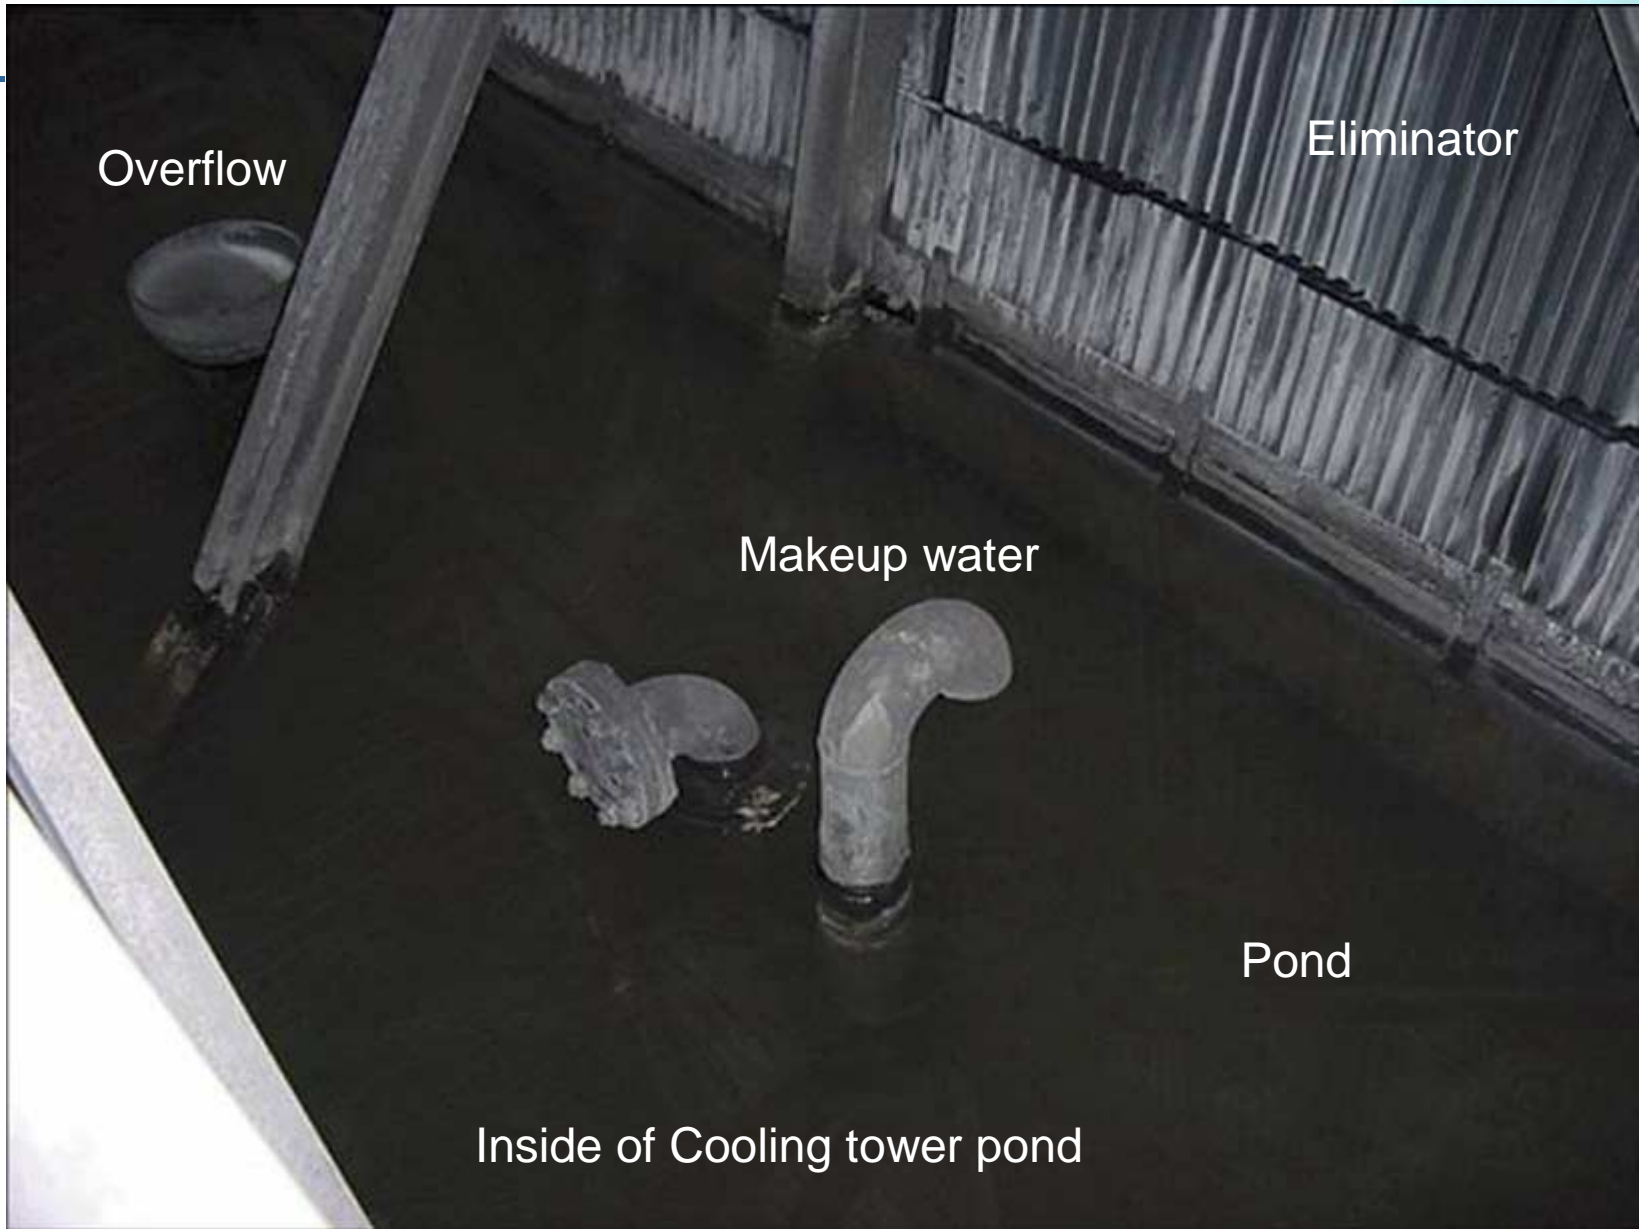
Overflow

Eliminator

Makeup water

Pond
